Nickel Sulphide Inclusions

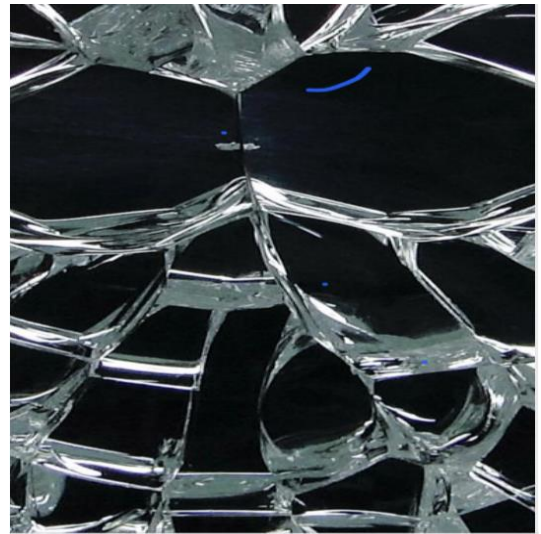
Image 1 (Right) - Example of Nickel sulphide breakage

When glass goes through the toughening process, it becomes four to five times stronger than standard annealed glass, making it great from a safety perspective. However, nickel sulphide stones that can form during the production of float glass due to nickel contamination, can end up in the centre tension zone of toughened glass. When the toughened glass is later exposed to varying temperatures in its final installed position, this tiny stone – which can measure from 0.1mm to 0.3mm in diameter – may grow in size, and cause the glass to shatter for no apparent reason.

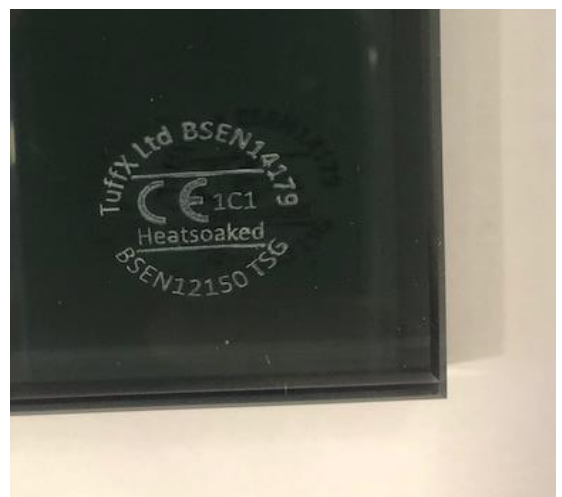
Image 2 (Right) – Glass stamped showing required information

All Infinity and Glow walk on floors are heat soaked to reduce the risk of breakage and stamped for assurance.
